The Thompson Falls Reservoir is formed by the Thompson Falls Dam on the Clark Fork River outside of Thompson Falls, Mont. The dam has been in operation since 1915 and is owned and operated by NorthWestern Energy.

Thompson Falls Reservoir Bank Stabilization Pilot Project

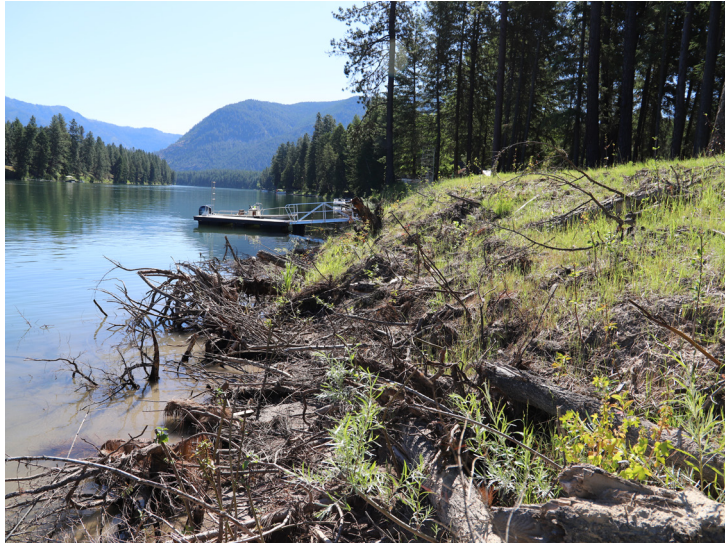
C The completed project, nine months after construction, features sloping banks down to a toe of wood, roots and shrubby vegetation, such as willow and red osier dogwood. The slope is planted with currant, chokecherry, Woods' rose, and cottonwood. A level bench provides suitable water access and dock anchor points.

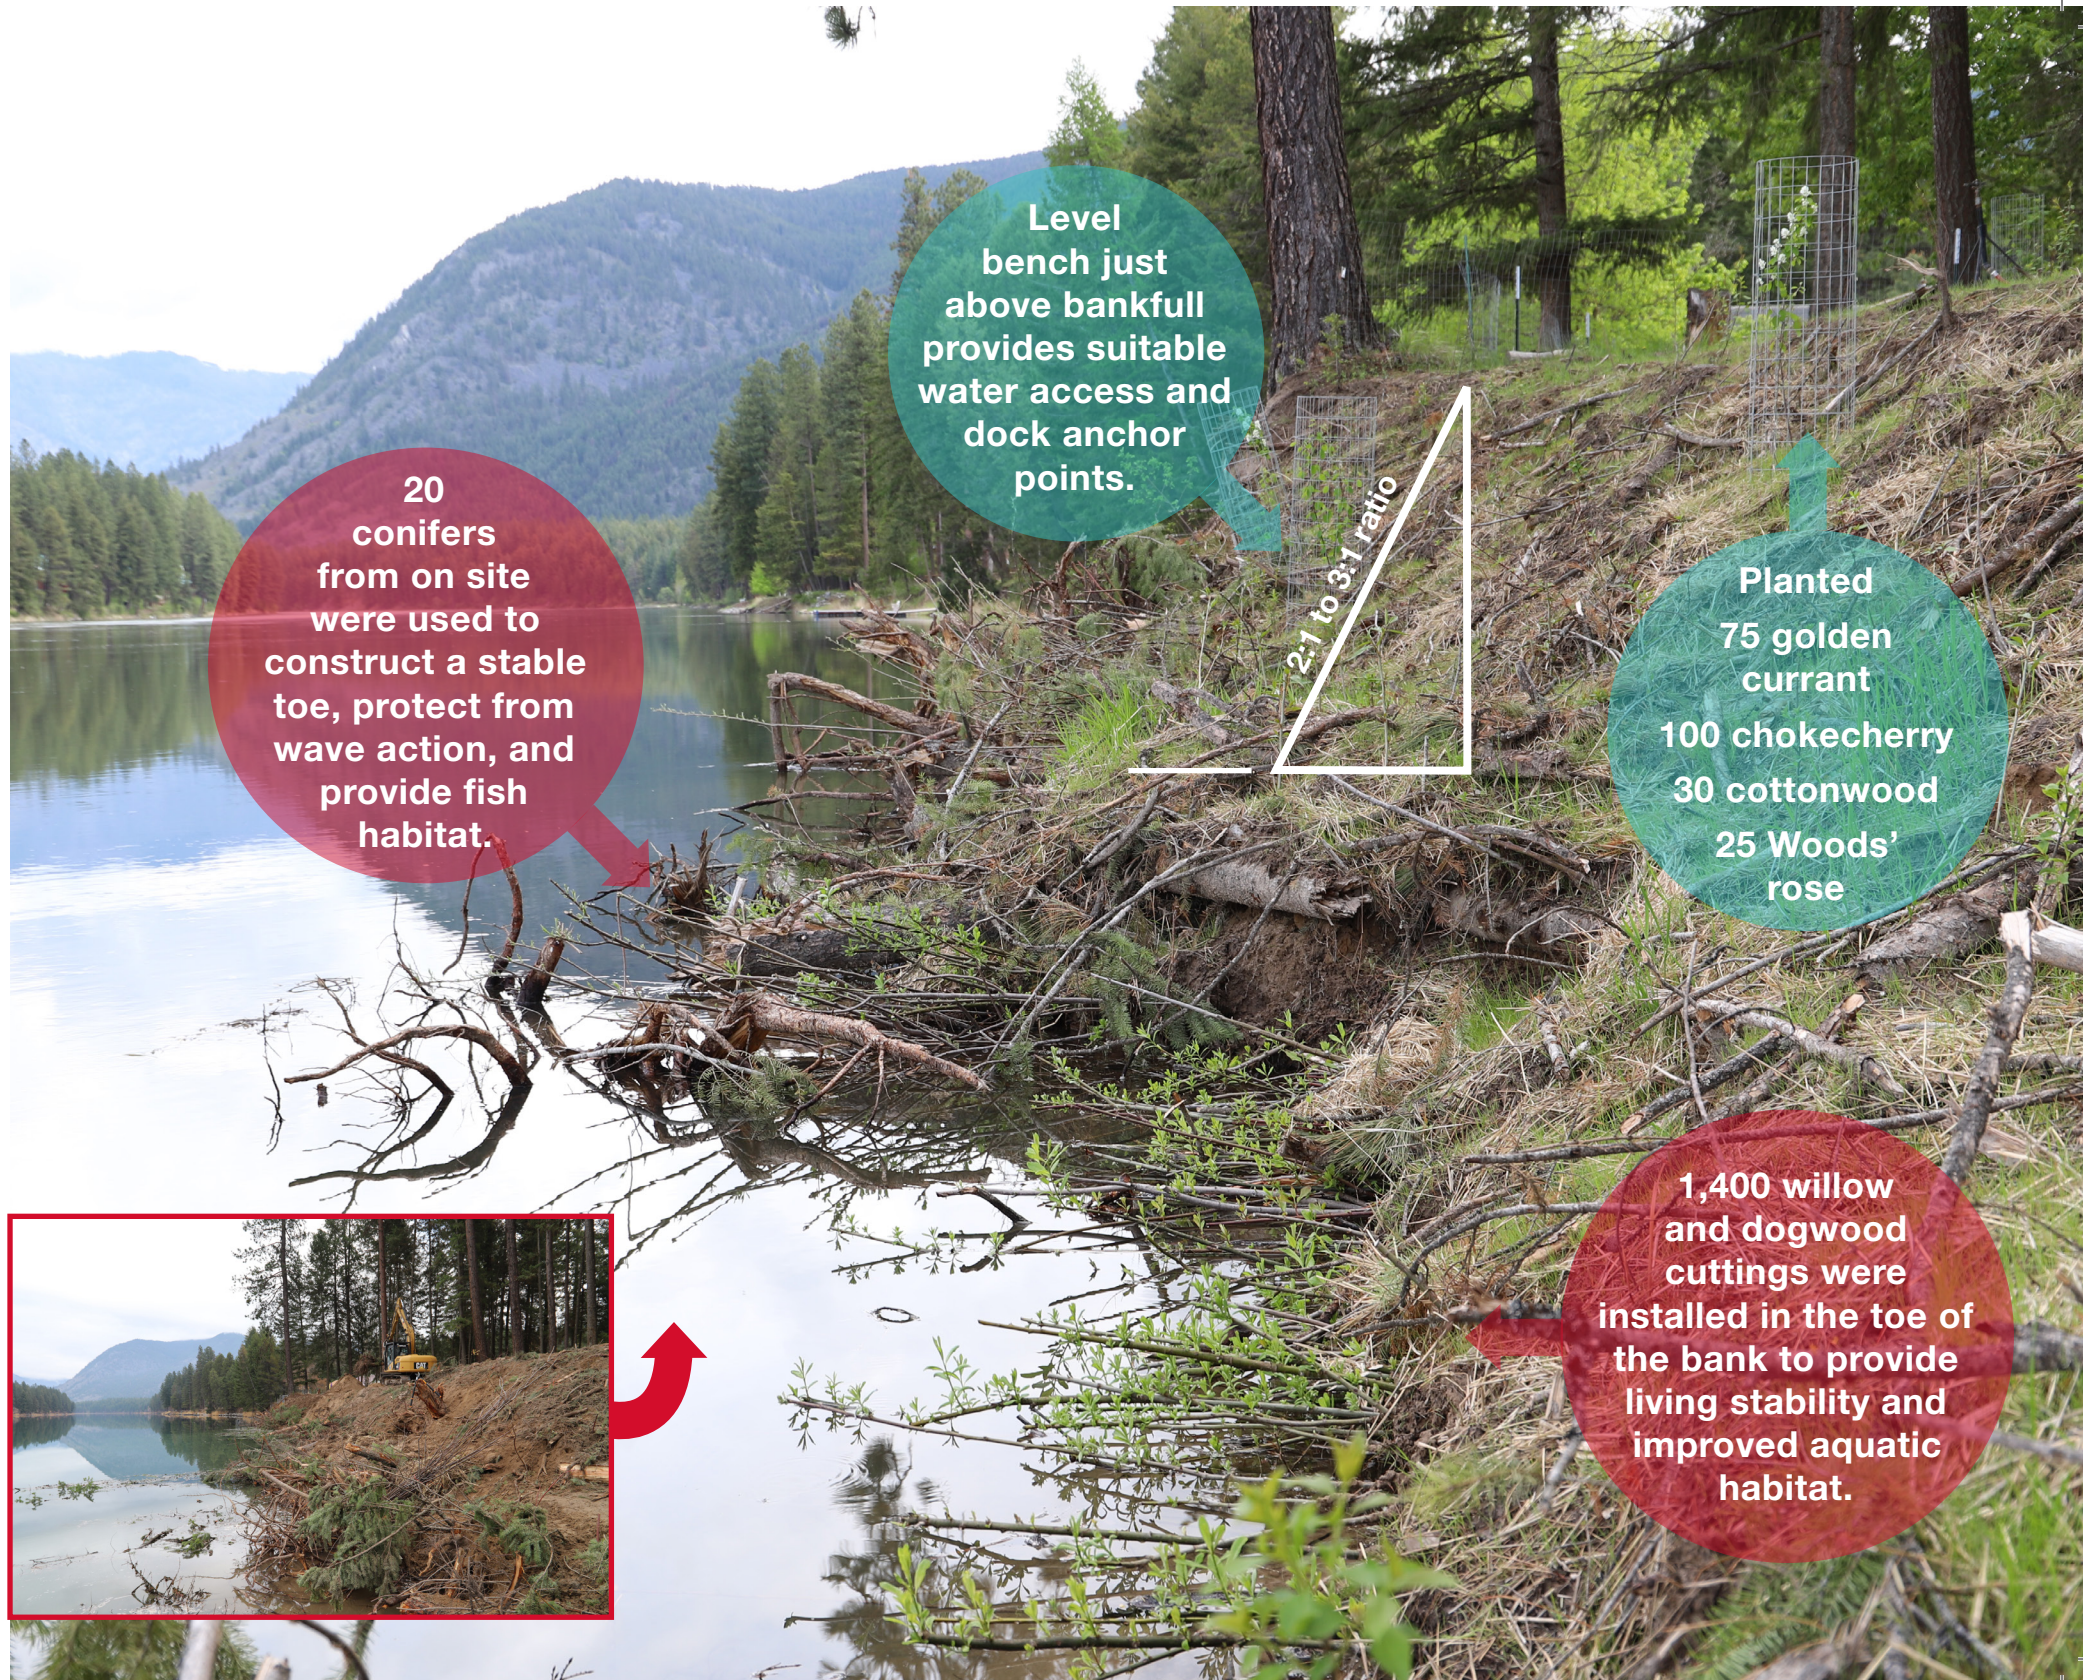
200 feet of eroding bank were identified for this project.

20 conifers from on site were used to construct a stable toe, protect from wave action, and provide fish habitat.

Level bench just above bankfull provides suitable water access and dock anchor points.

Planted
75 golden currant
100 chokecherry
30 cottonwood
25 Woods' rose

1,400 willow and dogwood cuttings were installed in the toe of the bank to provide living stability and improved aquatic habitat.
