**Little Prickly Pear Creek
Post-Flood Event Restoration
At Sieben Ranch**

Status Report for Northwestern Energy
FERC Project 2188

Project #2019-21

December 2019

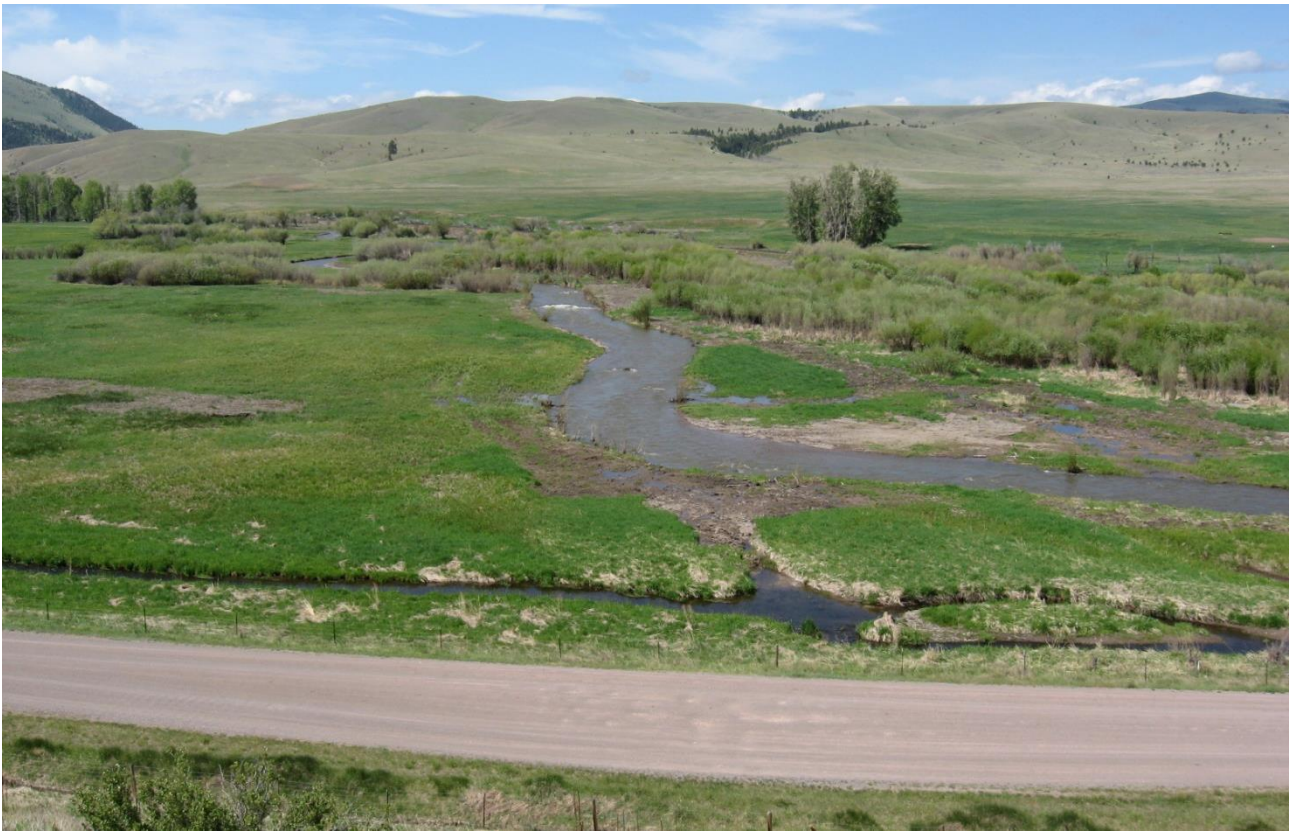
Photo 1. Little Prickly Pear Creek after 2014 channel construction and pre-2018 flood event. May 2014.

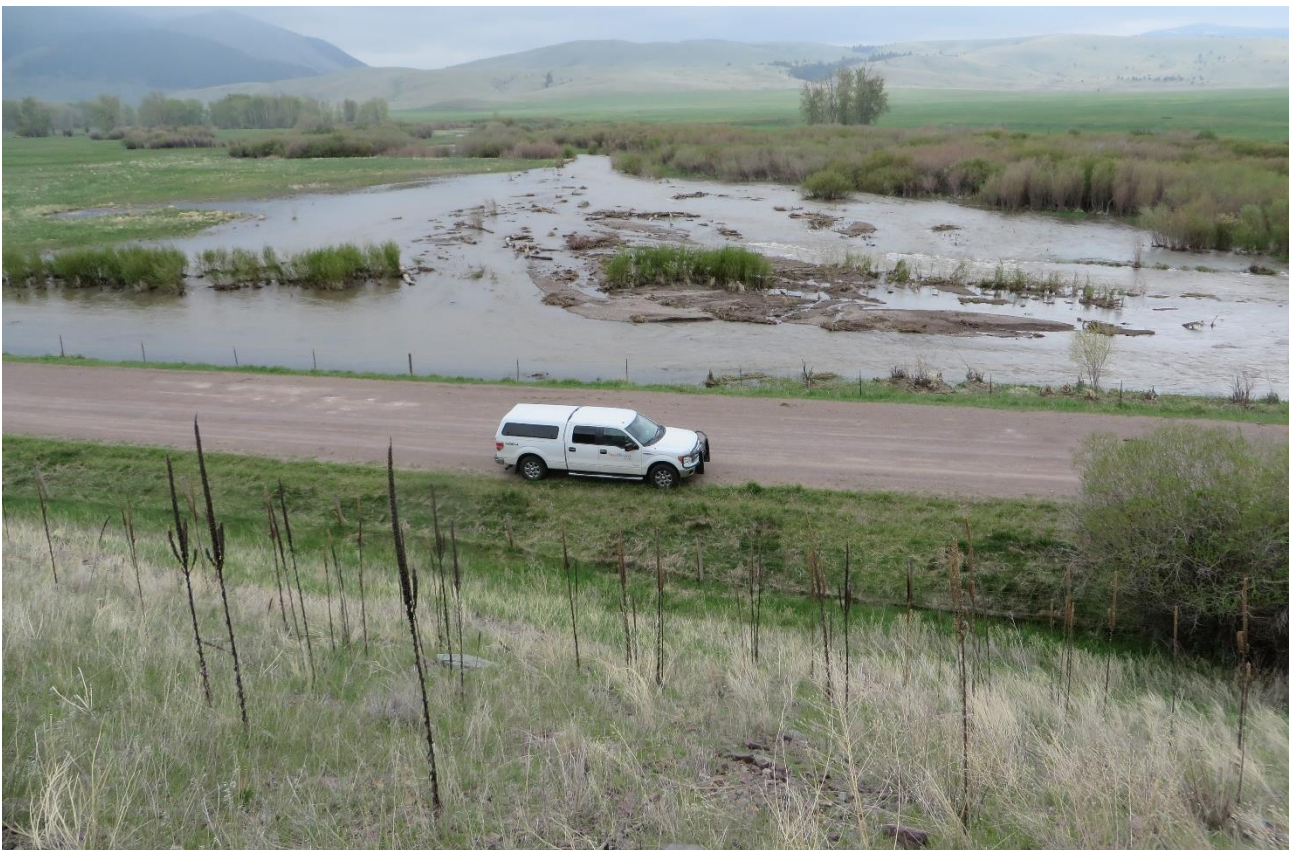
Photo 2. Little Prickly Pear Creek during 2018 flood event. May 17, 2018.

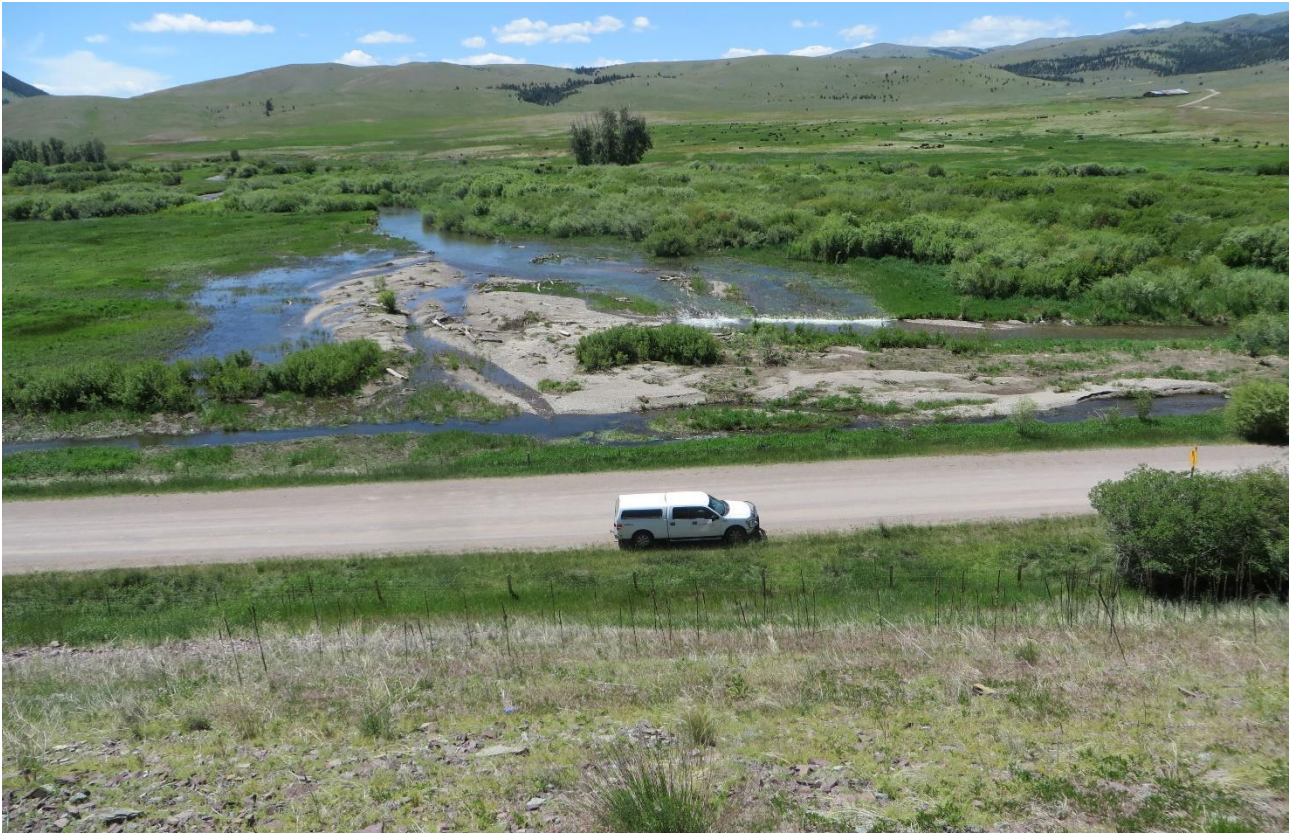
Photo 3. Little Prickly Pear Creek after 2018 flood event. June 14, 2018.

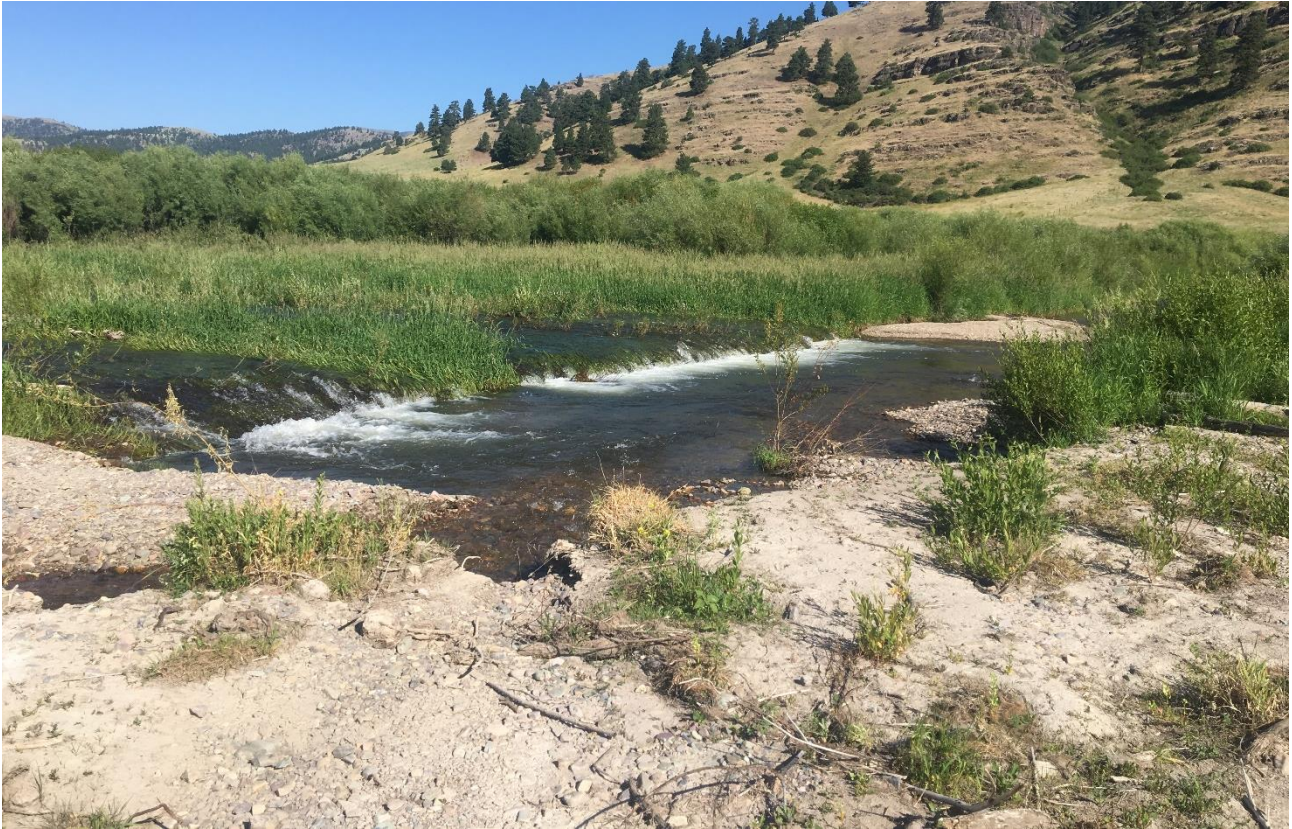
Photo 4. Little Prickly Pear Creek after 2018 flood event. July 16, 2018.

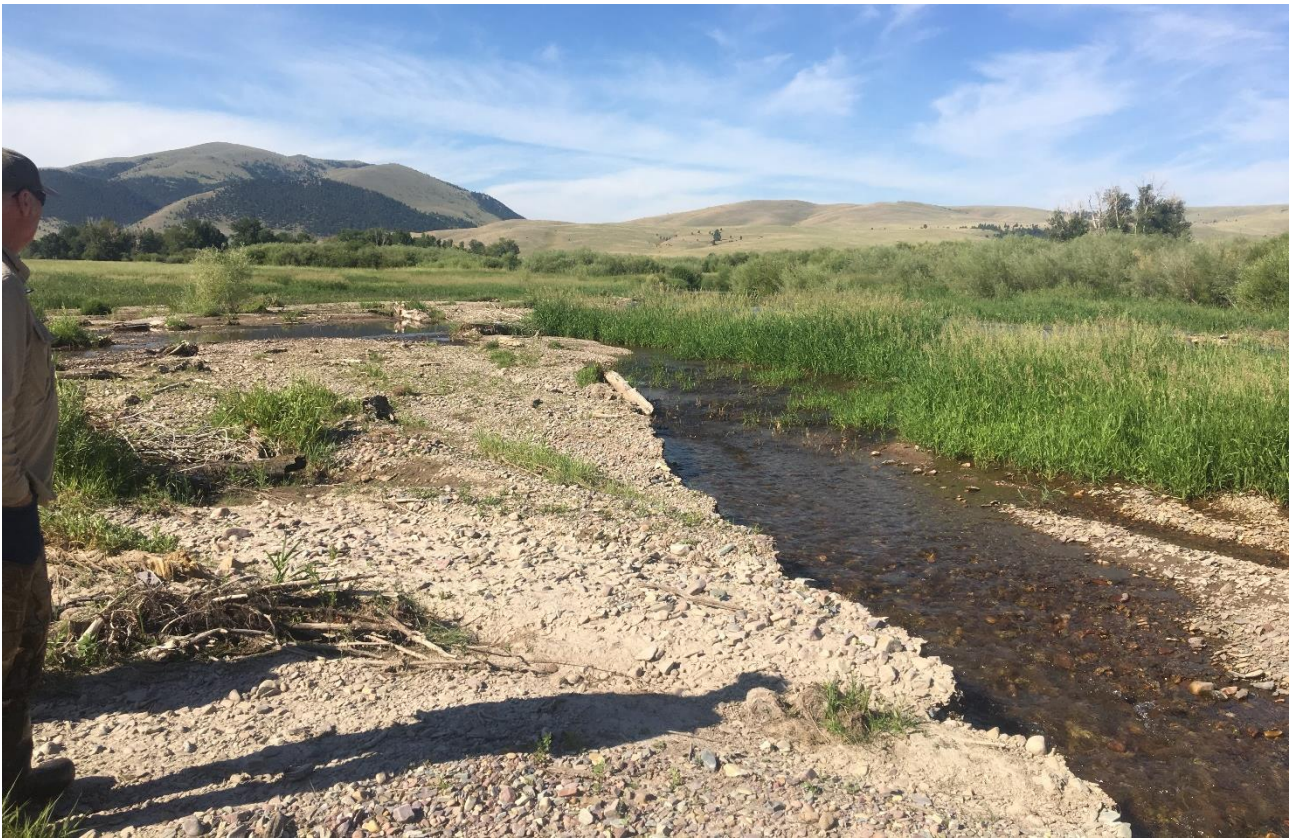
Photo 5. Little Prickly Pear Creek after 2018 flood event. July 16, 2018.

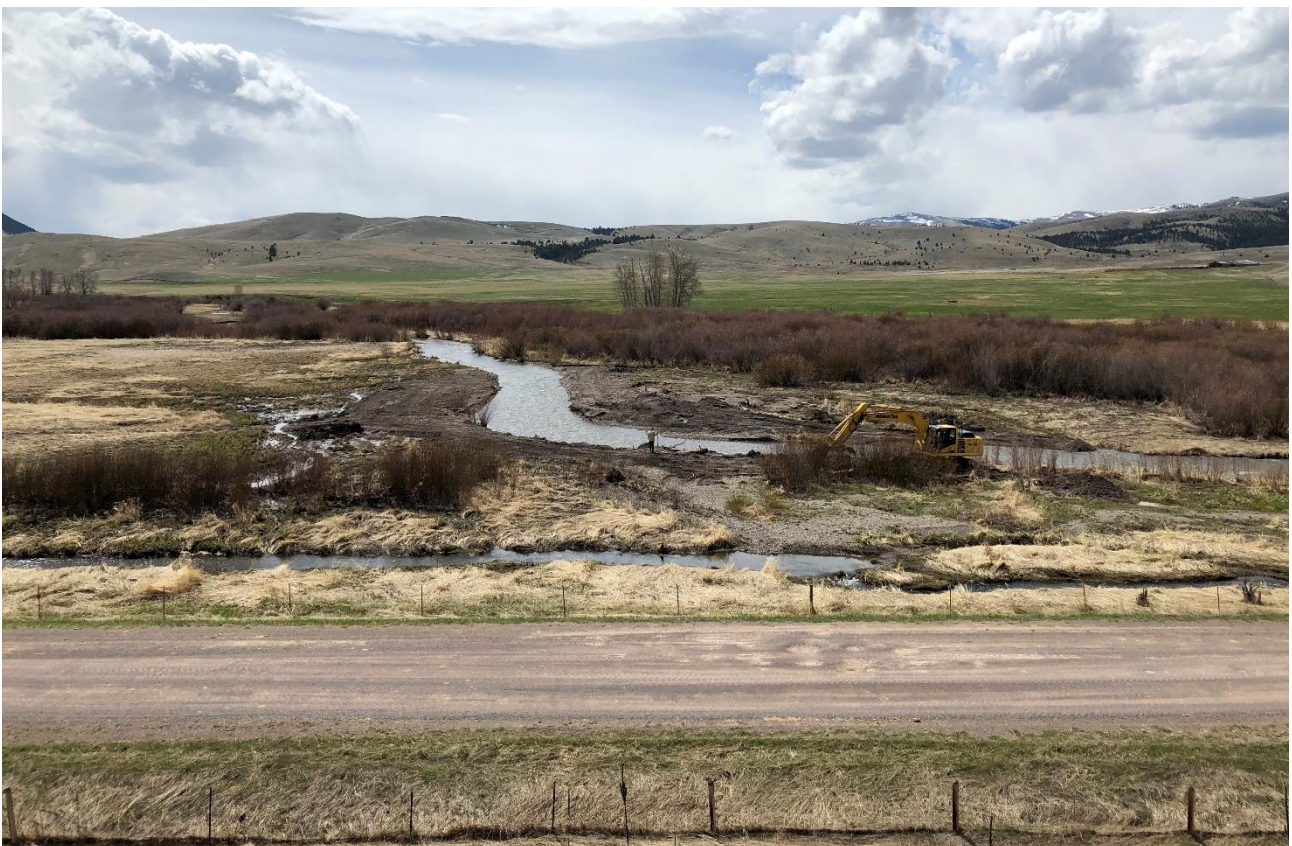
Photo 6. Little Prickly Pear Creek after 2018 flood event, during restoration. May 1, 2019.

The restoration approved by the MoTAC and permitted by the appropriate agencies was completed in late April and early May 2019. The restoration and maintenance consisted of removal of the stream channel plug and stabilizing and redefining the existing channel. Rock grade control structures were also constructed in two areas of active headcuts to prevent further channel down cutting. Rock grade control structures were constructed with 2 ft minus rock and built to the stream grade to prevent a similar occurrence from happening in the future.

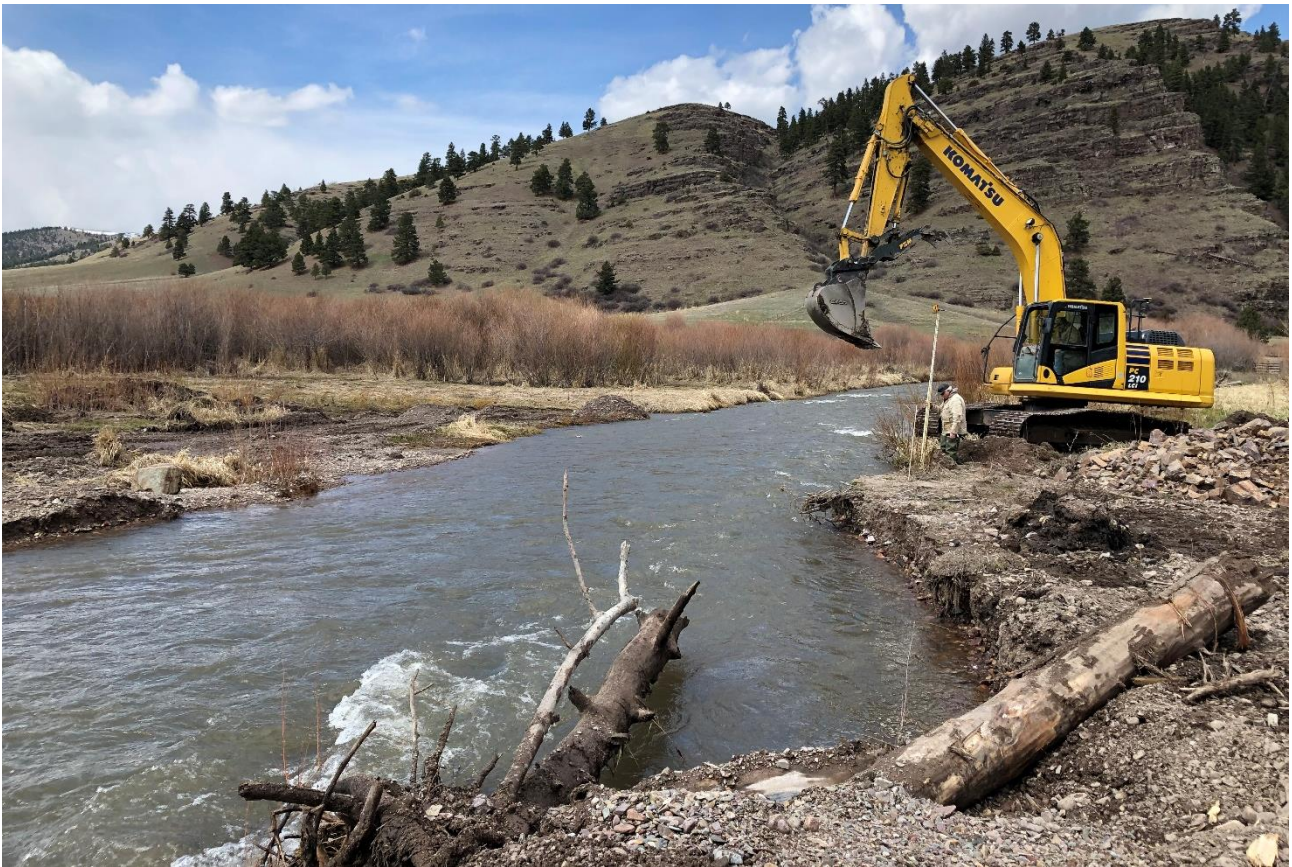
Photo 7. Little Prickly Pear Creek after 2018 flood event, during restoration. May 1, 2019.

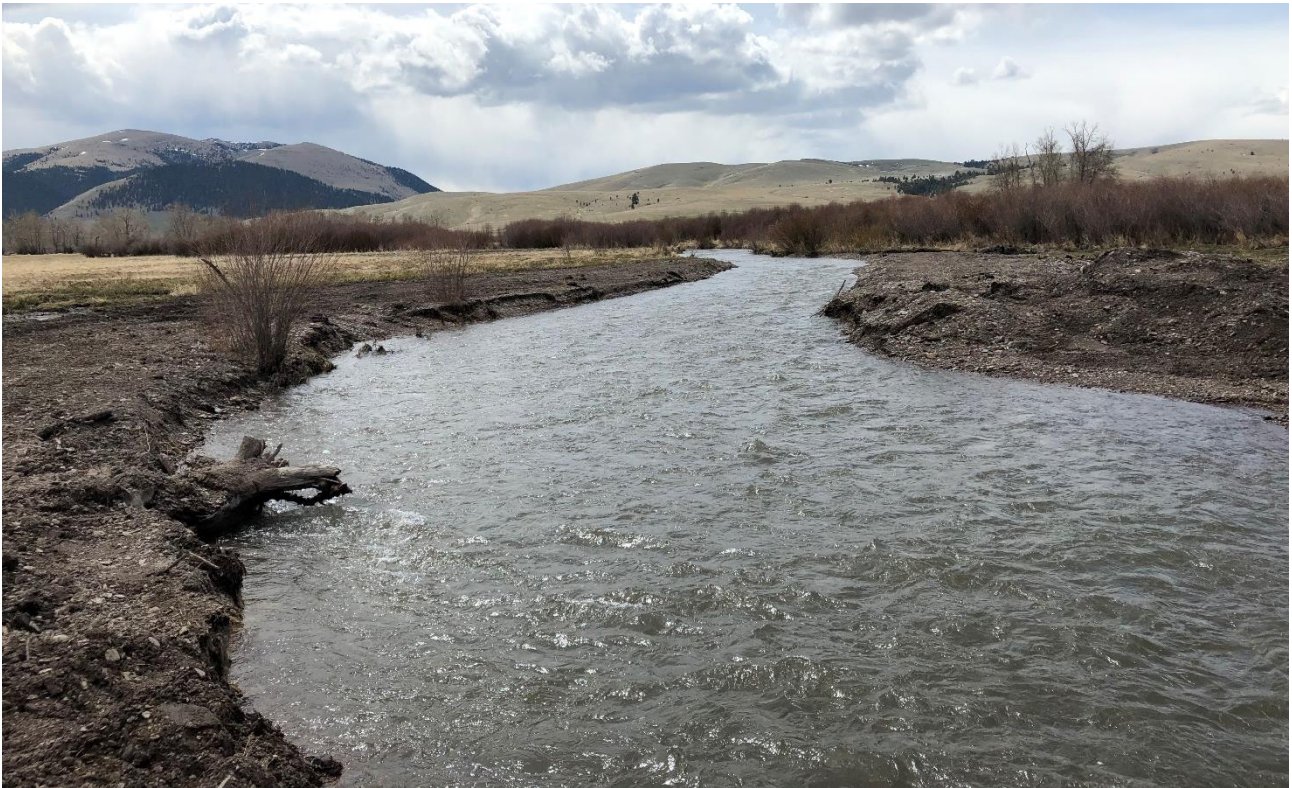
Photo 8. Little Prickly Pear Creek after 2018 flood event, during restoration. May 1, 2019.

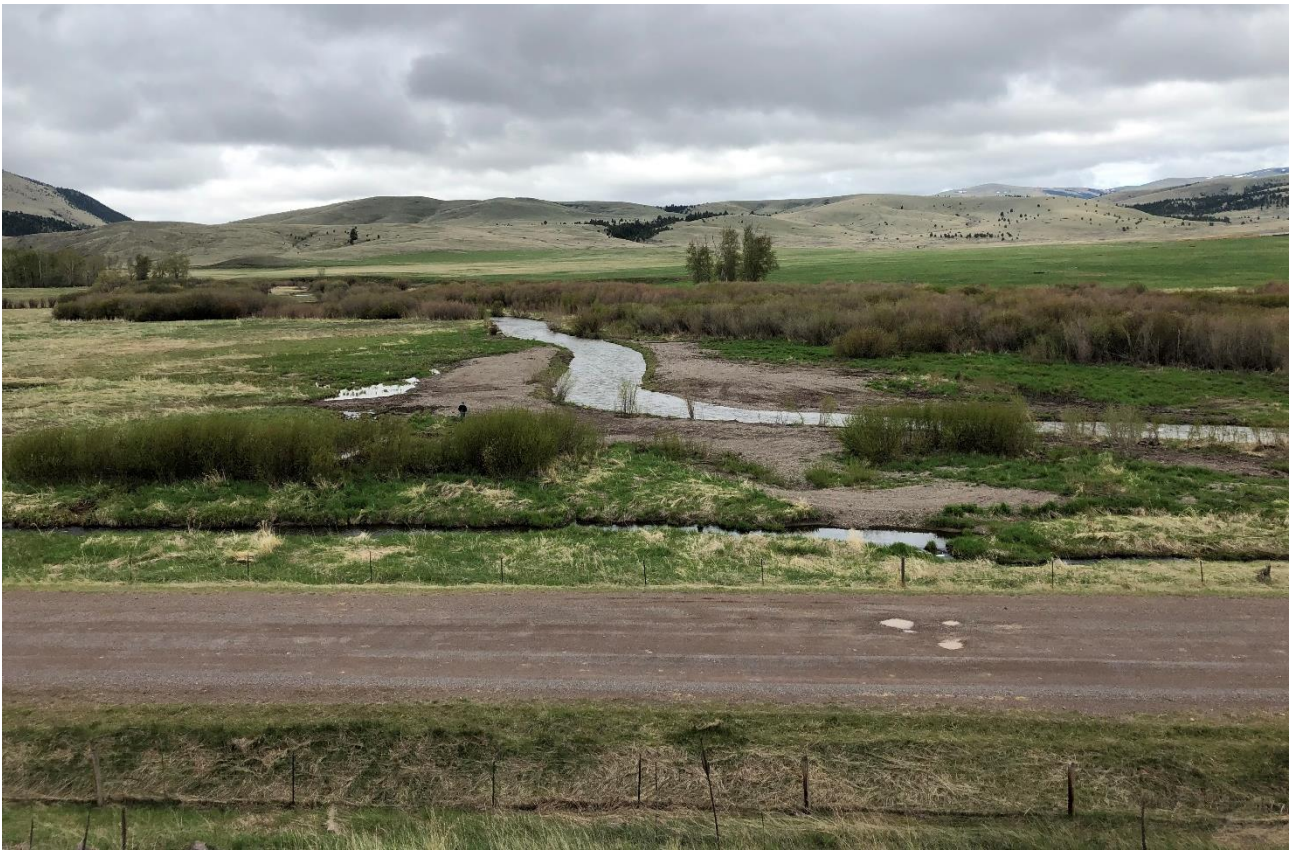
Photo 9. Little Prickly Pear Creek after 2018 flood event, after restoration. May 21, 2019.

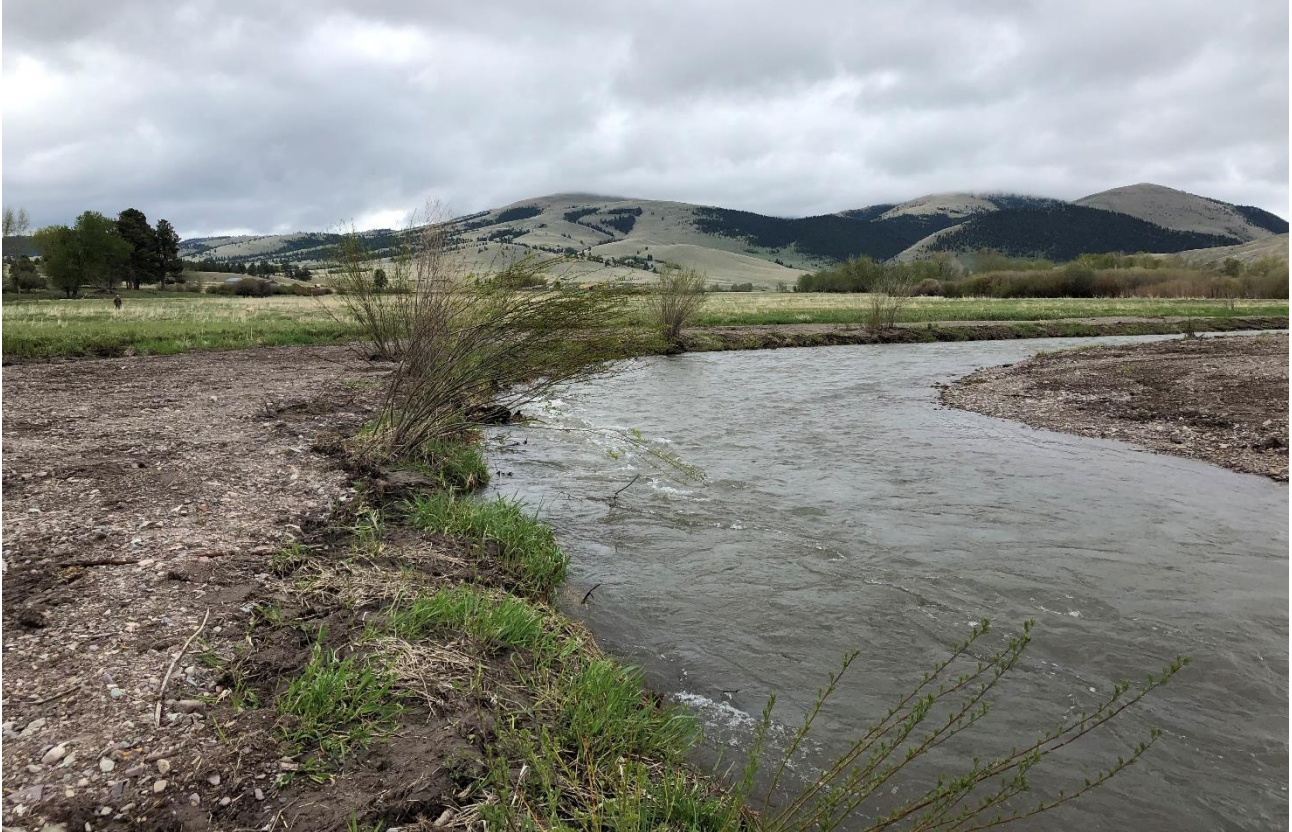
Photo 10. Little Prickly Pear Creek after 2018 flood event, after restoration. May 21, 2019.

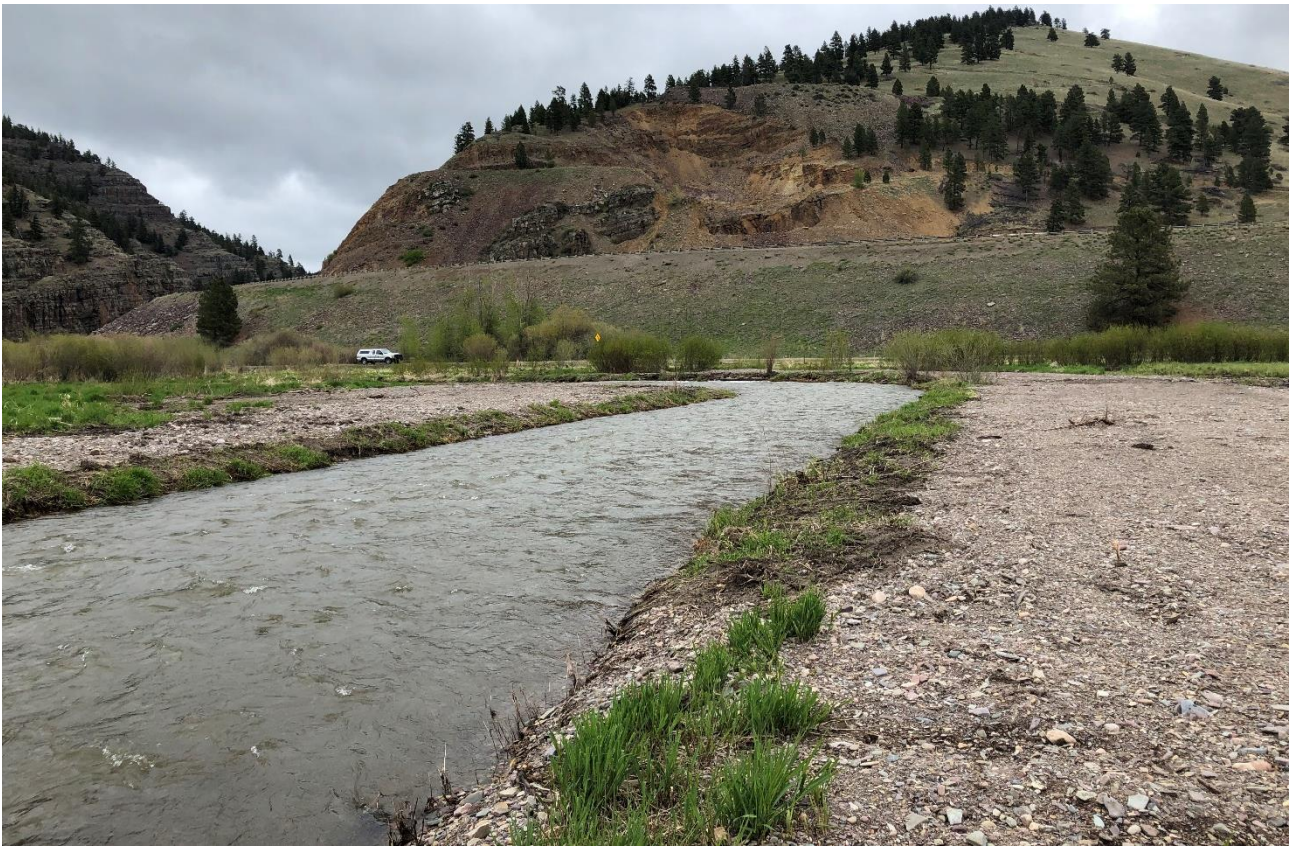
Photo 11. Little Prickly Pear Creek after 2018 flood event, after restoration. May 21, 2019.

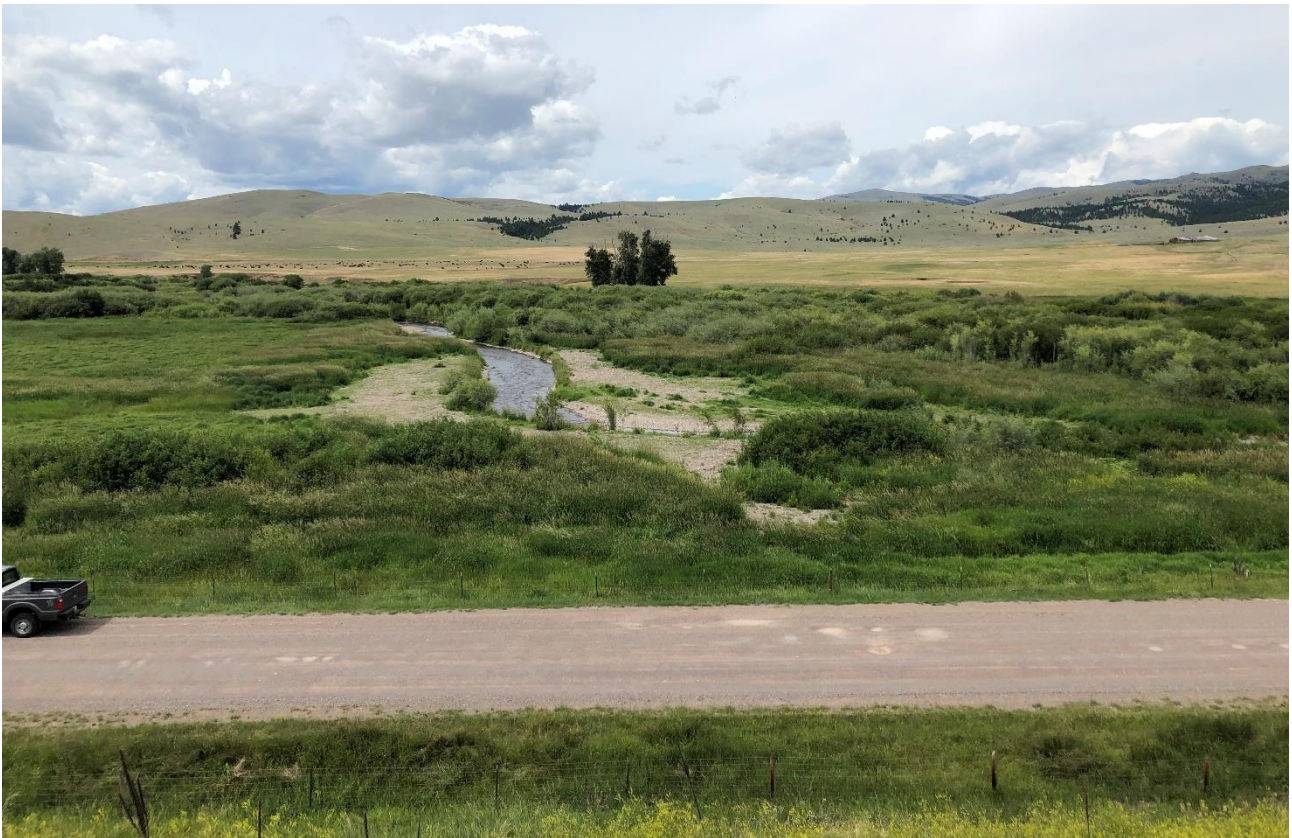
Photo 12. Little Prickly Pear Creek after 2018 flood event, after restoration. July 16, 2019.
