The Thompson Falls Reservoir is formed by the Thompson Falls Dam on the Clark Fork River outside of Thompson Falls, Mont. The dam has been in operation since 1915 and is owned and operated by NorthWestern Energy.

Thompson Falls Reservoir Bank Stabilization Pilot Project

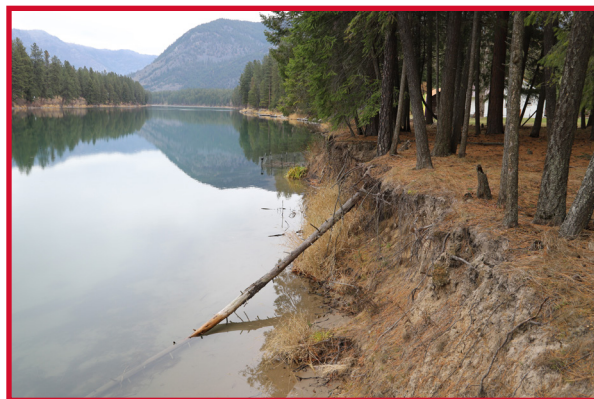
200 feet of eroding bank were identified for this project.

20 conifers from on site were used to construct a stable toe, protect from wave action, and provide fish habitat.
